USAAVLABS TECHNICAL REPORT 66-24

AIRCRAFT FUEL TANK DESIGN CRITERIA

U. S. ARMY AVIATION MATERIEL LABORATORIES
FORT EUSTIS, VIRGINIA
CONTRACT DA 44-177-AMC-254(T)
AVIATION SAFETY ENGINEERING AND RESEARCH
A DIVISION OF
FLIGHT SAFETY FOUNDATION, INC.
PHOENIX, ARIZONA

Technical Report
AvSER 65-17

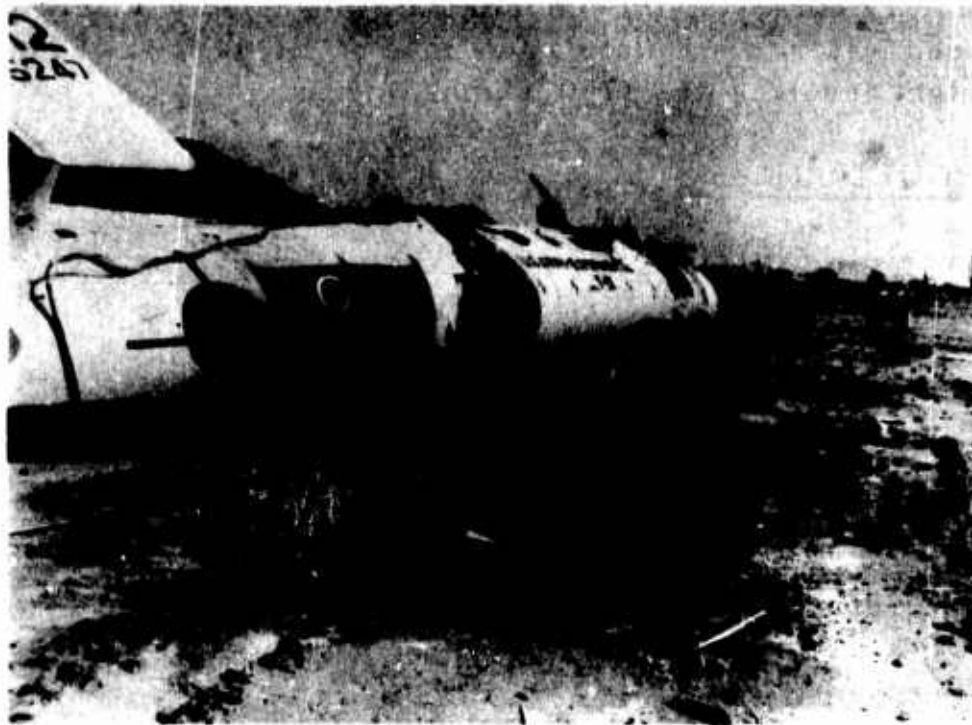
A relatively mild impact resulted from T-12. Overall structural damage to the fuselage was minor, as shown in Figure 11.

Figure 11. Condition of Helicopter After T-12 Crash.

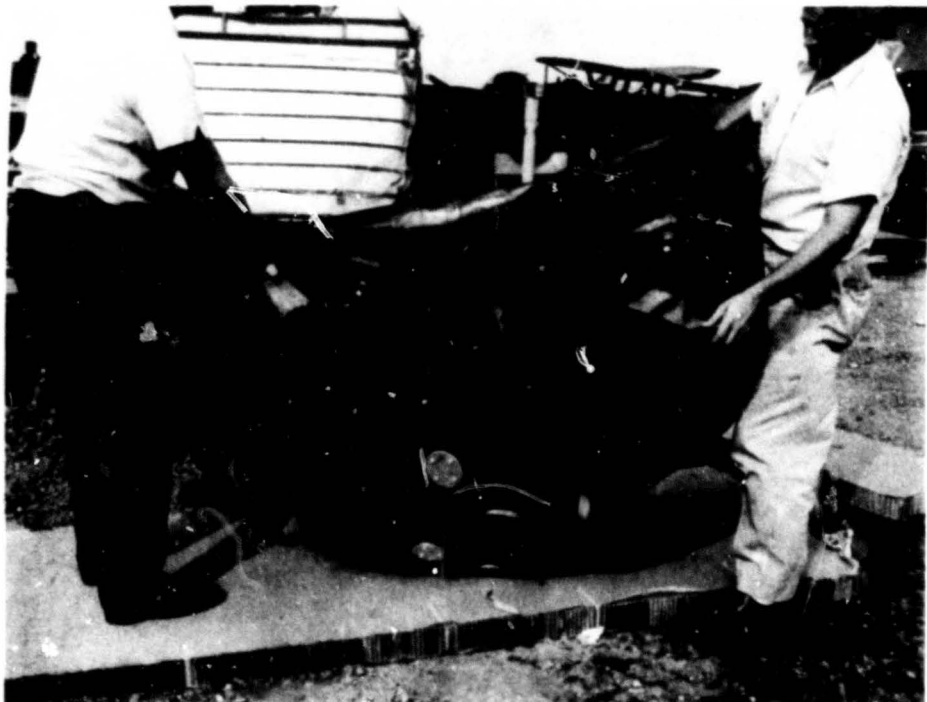
The fuel cell sustained only two small slit-like perforations, 6 inches apart on the bottom, 1 foot from the instrumentation housing. These are shown in Figures 18 and 19. The perforations measured 1/2 and 1 inch, respectively, and occurred when the longitudinals, shown exposed in Figure 20, sheared upward. Figure 21 depicts the jagged metal that punctured the fuel cell bottom.

Figure 18. Fuel Cell After T-12 Crash (Perforations Outlined in Tape).

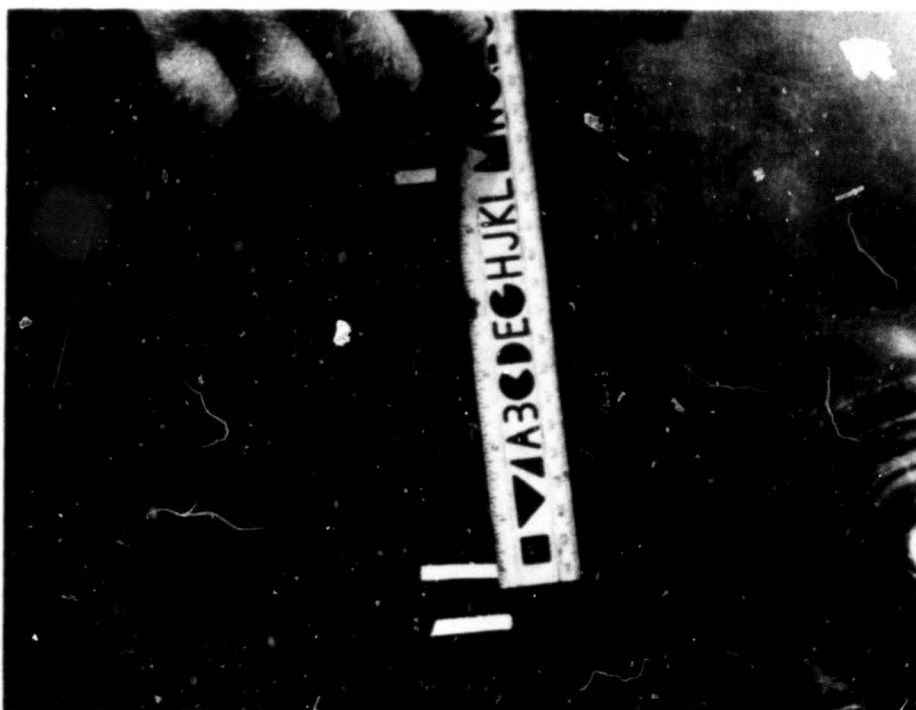
Figure 19. Close-up of T-12 Perforations.

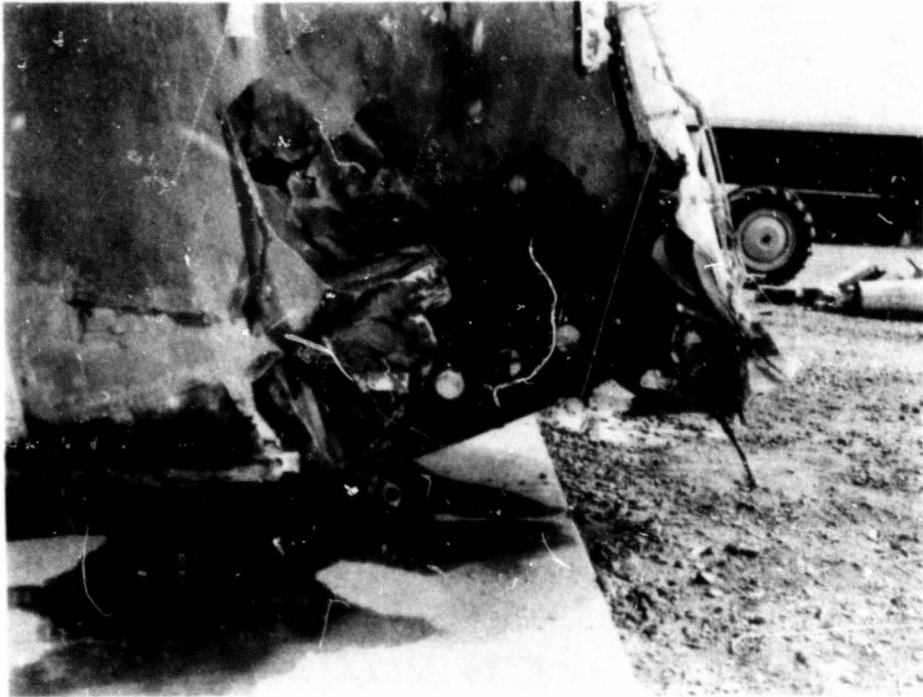
Figure 20. Deformation of Fuel Cell Chamber, Left Side, From T-12.

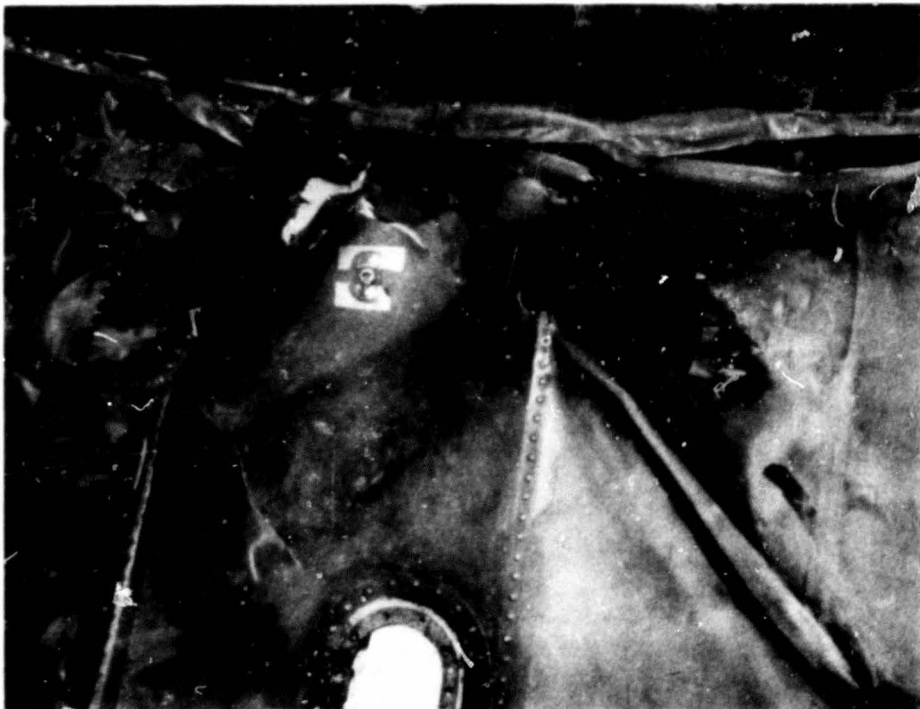
Figure 21. Interior View of Cell Chamber Showing Area Where Fuel Cell Was Punctured.

The crash forces recorded in this test were well below survivable limits as presently known. The cell puncture caused by the jagged metal shown in Figure 21 started leakage of sufficient rate for ignition by the oil fire, through abraded sparks, contact with heated metals, or any of the ignition potentials present in an aircraft crash, had actual fuel been carried in the tank. The fact that the crash forces were well within

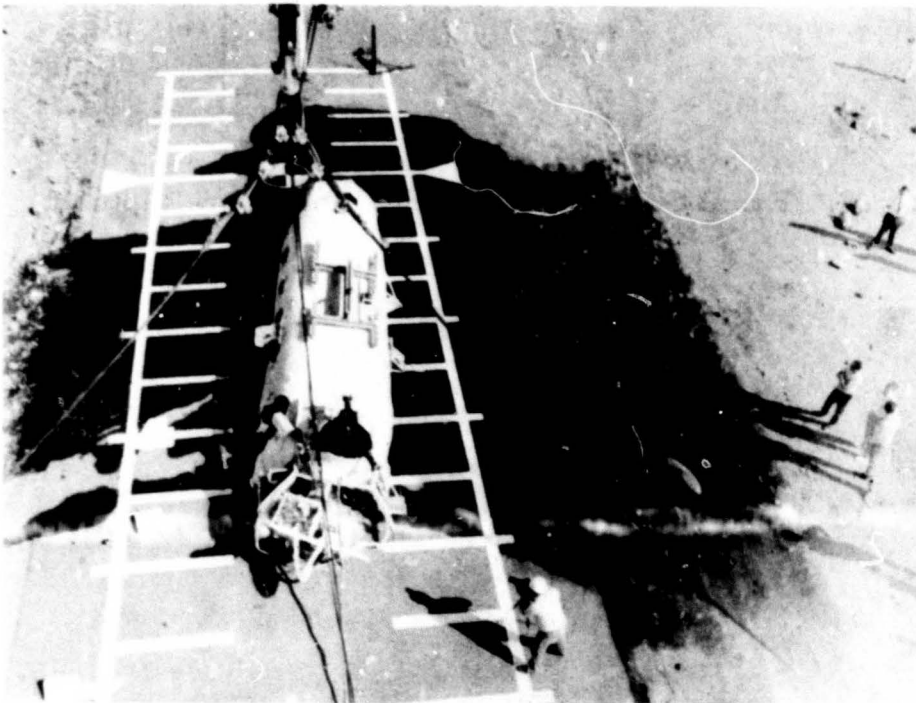
Figure 26. T-13 Exterior Fuel Spillage Pattern.

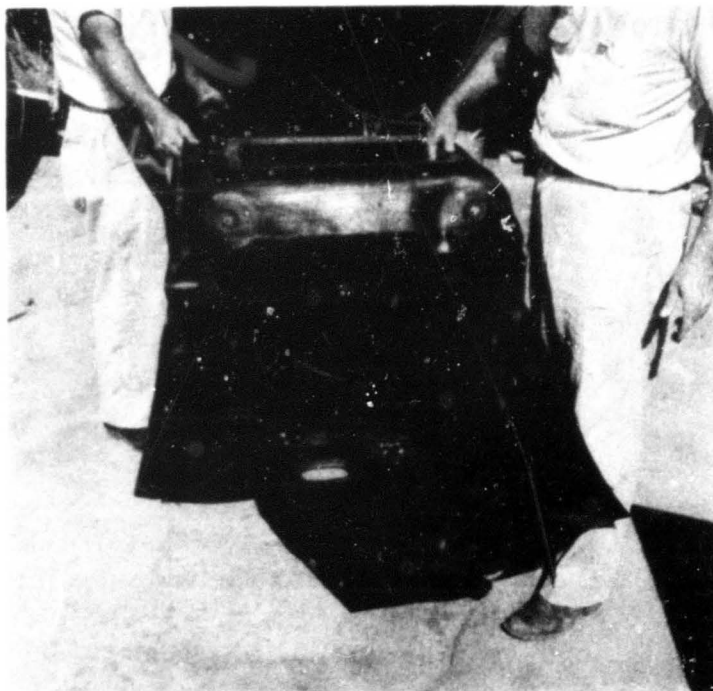
Figure 28. Left Side of Ruptured Fuel Cell.

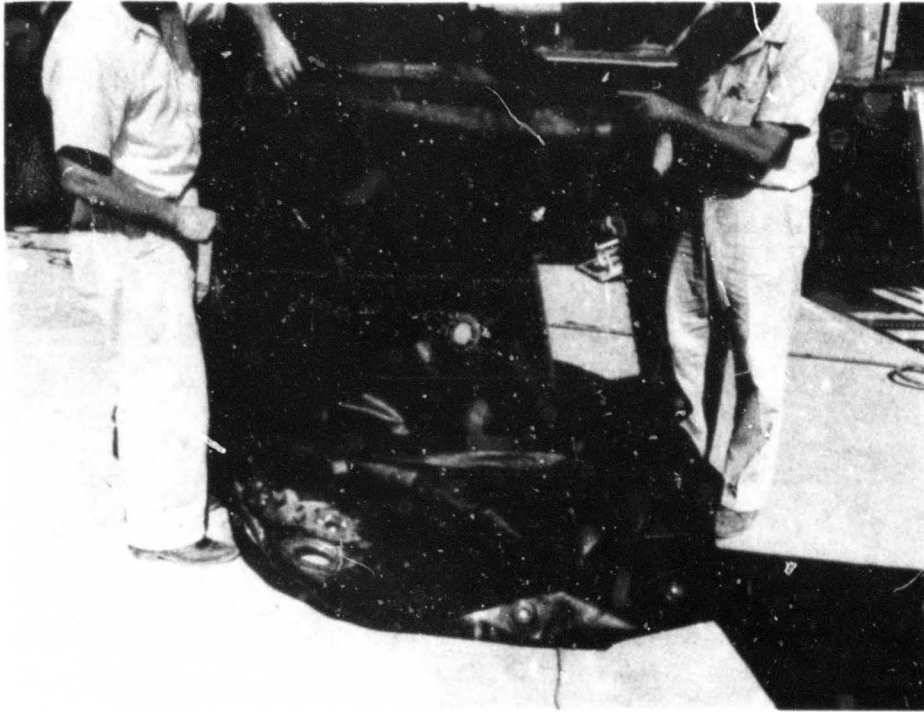
Figure 29. Size of Opening Demonstrated.

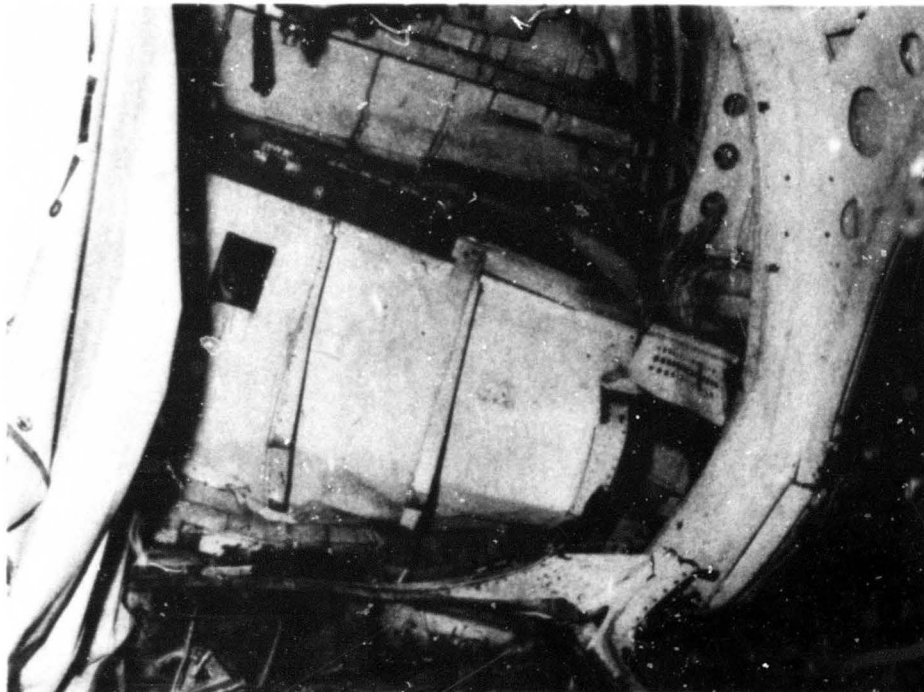
Figure 30. Forward View of Fuel Chamber Damage.

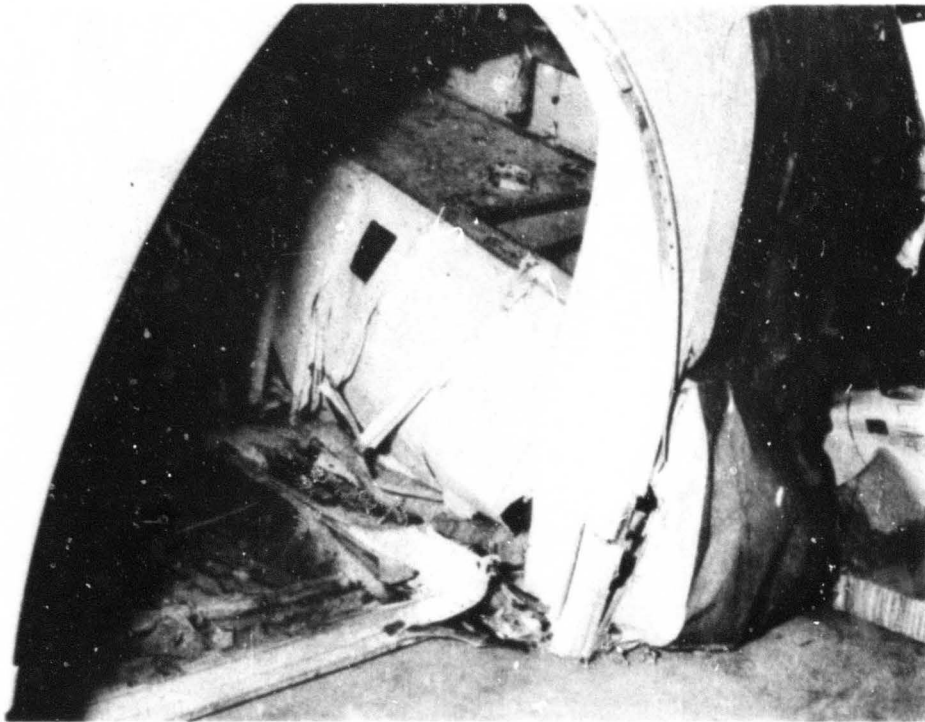
Figure 31. View Showing Forward Deformation of Front of Fuel Chamber Structure.

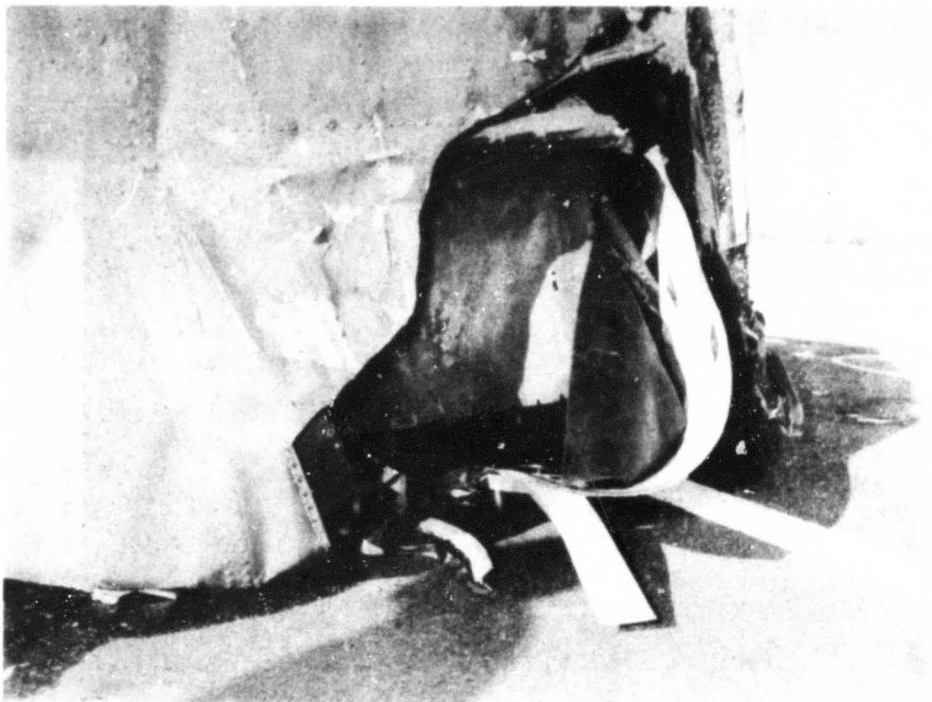
and 32. These pictures also indicate that the pressure surge was primarily in a forward and left direction.

Figure 32. Opening Created in Left Side of Fuel Chamber.

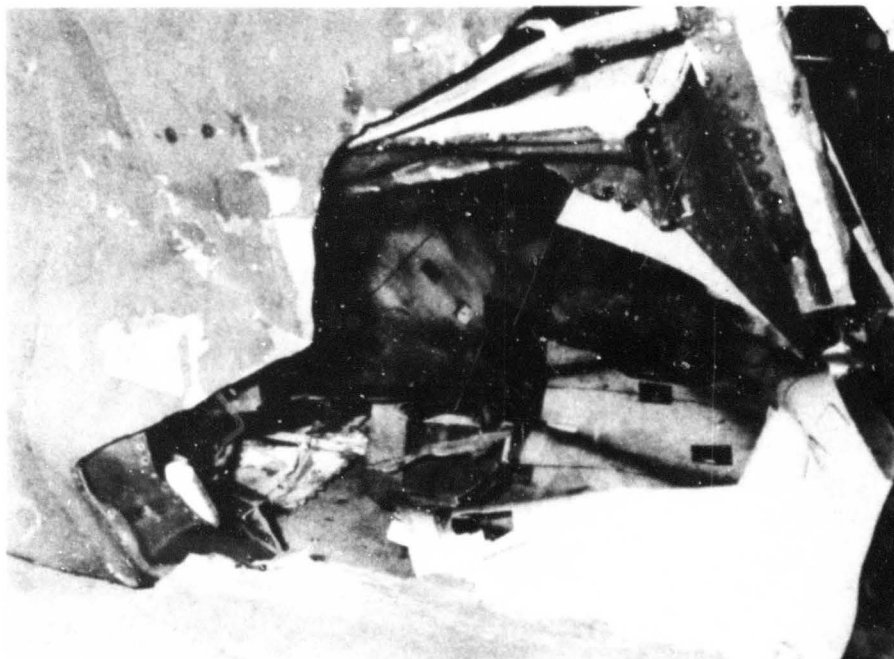
The nylon liner sustained no rips or perforations. Figures 33 and 34 show the position and condition of the liner with the fuel cell removed. Upon impact and during the chamber deformation, the liner followed the metal to which it was fastened. Where separation occurred between the liner and the chamber wall, the rivets pulled through the metal and remained with the liner. The corner taping offered only minor resistance to seam separation and tore or ripped indiscriminately.

Figure 33. Liner Position After Test.

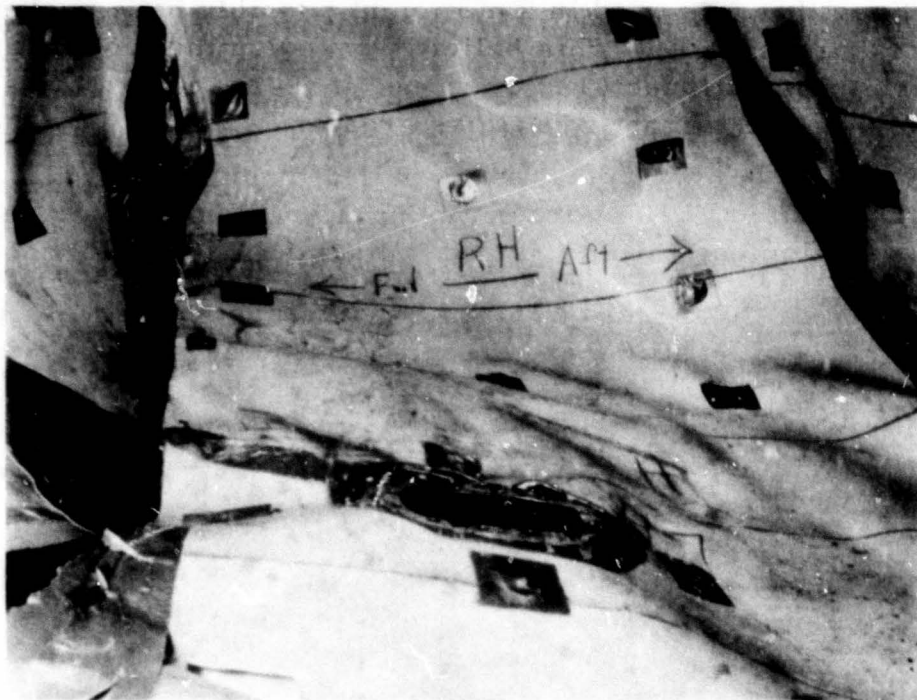
Figure 34. Postcrash Condition of Liner and Edge Taping.

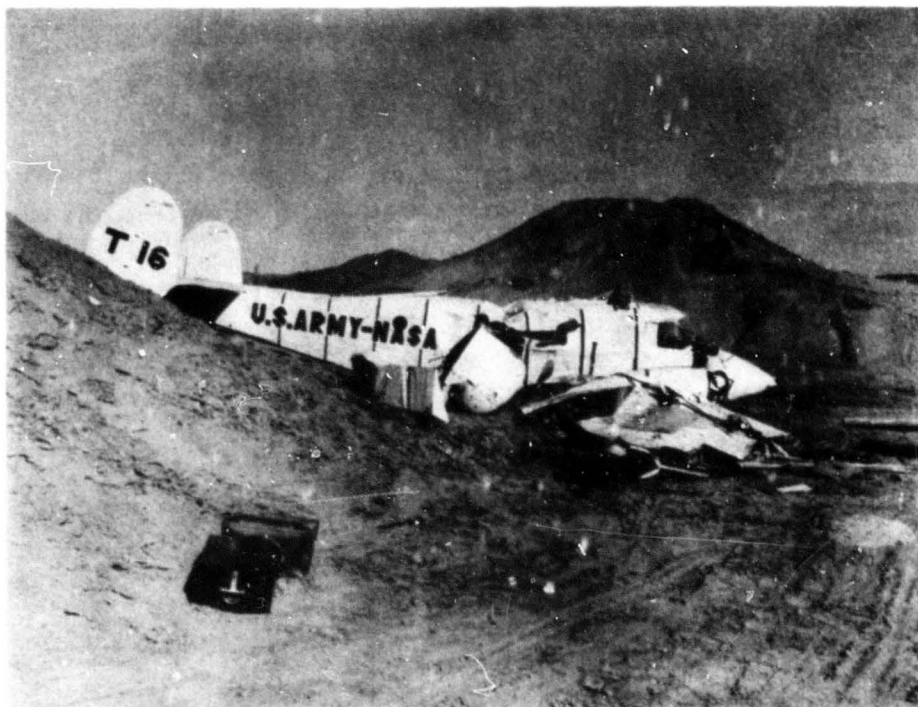
Figure 39. Damage to Aircraft Right Side, T-16.

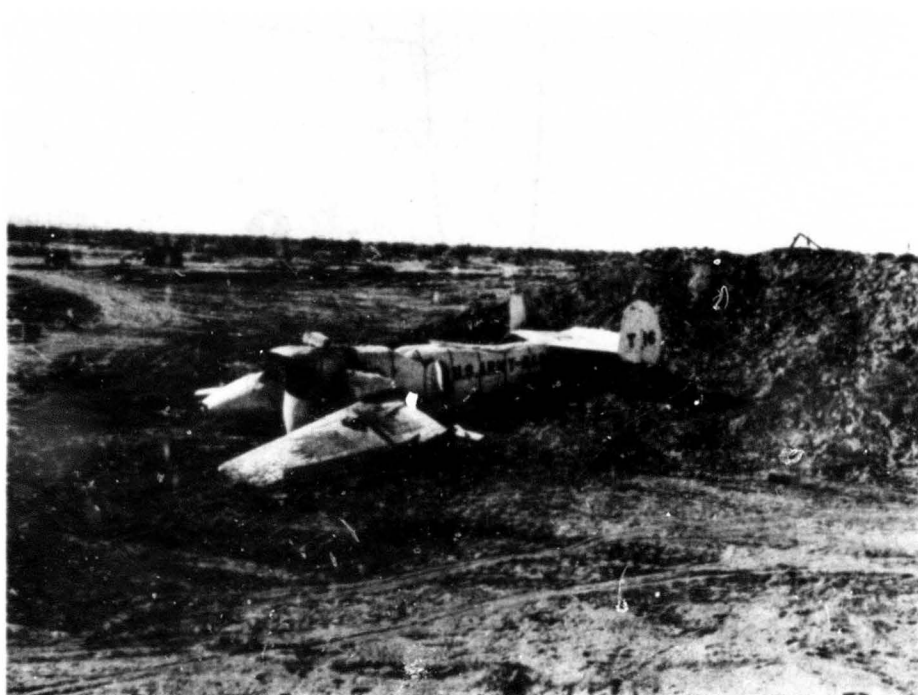
Figure 40. Damage to Aircraft Left Side, T-16. (Note That the Left Wing Nearly Severed By Hill Impact Continued Forward, Coming to Final Rest in a Swept-Forward Position.)

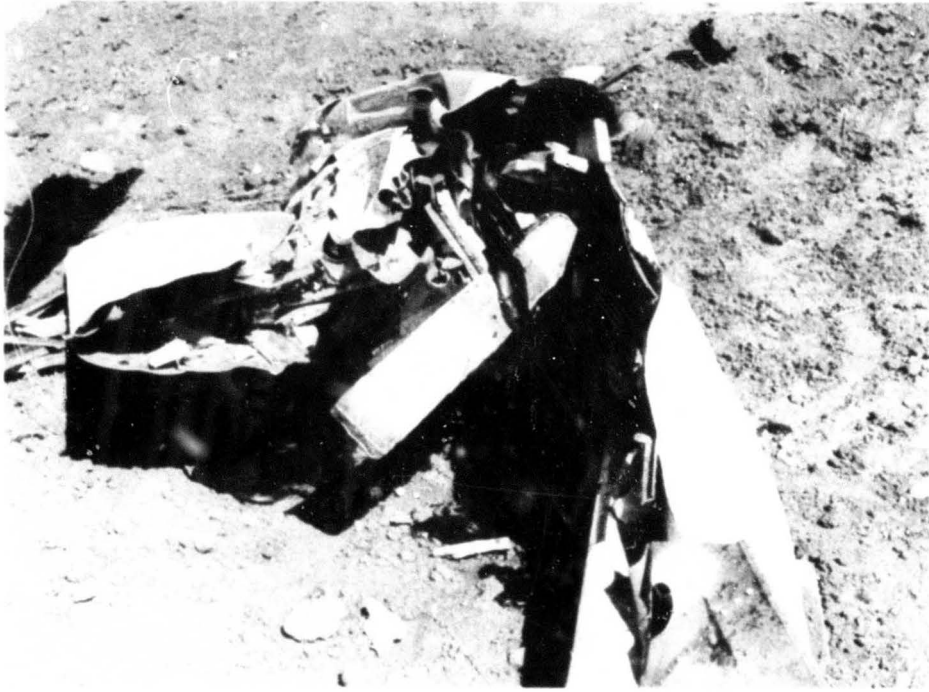
The aircraft accelerated to a speed of approximately 96 mph, or slightly over 140 feet per second, at the end of the 2,000-foot run. Both of the tanks impacted by the telephone poles in the right wing and the inboard tank in the left wing failed in this test. The damage to the right and left wings of the aircraft is shown in Figures 39 and 40. Typical damage to these tanks is shown in Figures 41 and 42.

Figure 41. Right Wing Tank, T-16. (At Impact With the Pole, These Tanks Were "Accordioned" Rearward into the Structure.)

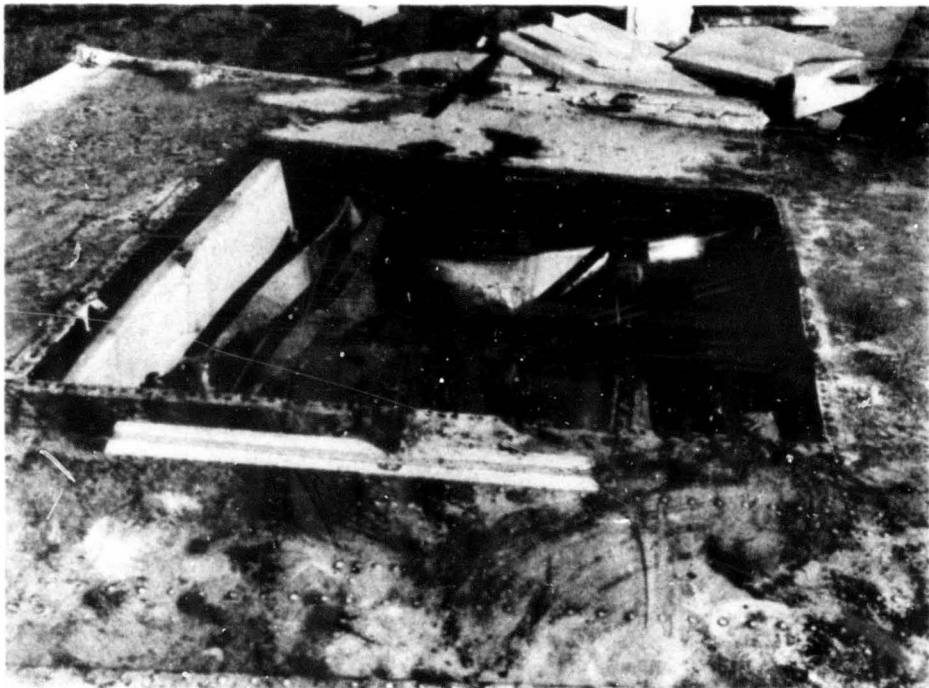
Figure 42. Left Wing Root Tank, T-16. (At Hill Impact, These Tanks Expanded in the Forward Half and Collapsed in the Aft Half.)

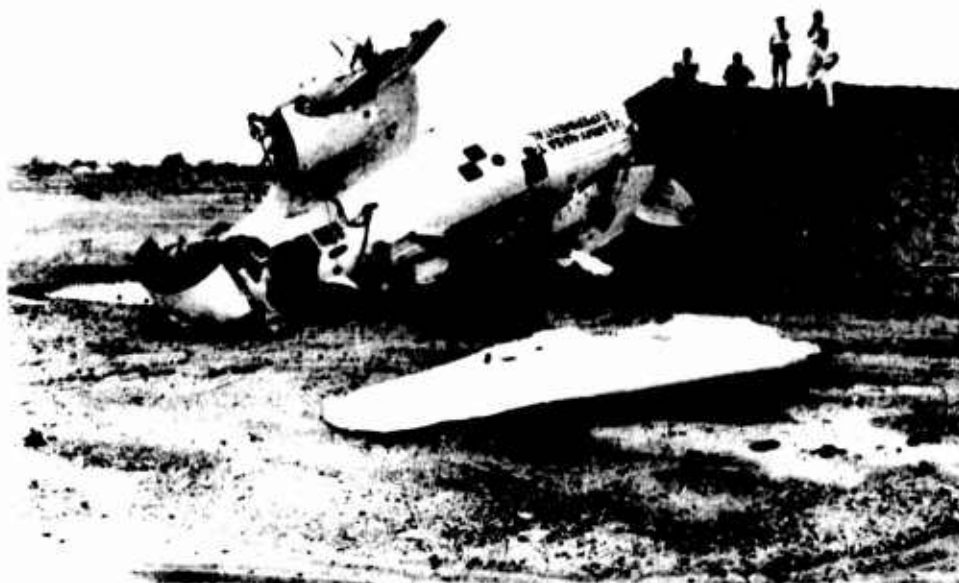
Figure 46. Postcrash View of Aircraft, T-19. (The Left Wing Was Torn Free at Hill Impact and Came to Rest Ahead of the Main Wreckage.)

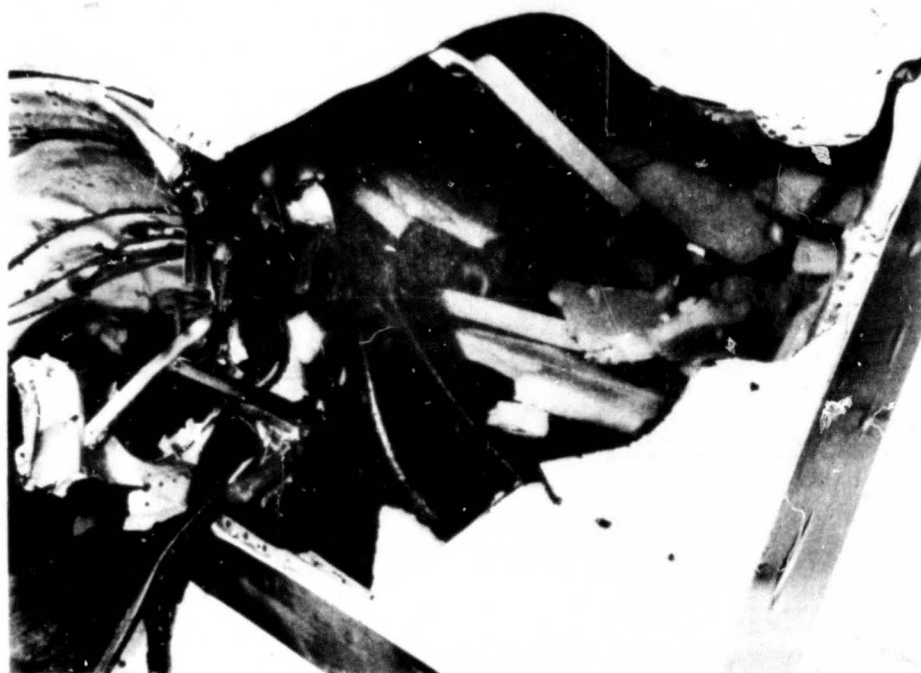
Figure 50. Right Wing Outboard Tank - In Place, T-19.
(The Tank Was Displaced Rearward by the Caved-in Leading Edge of the Wing.)

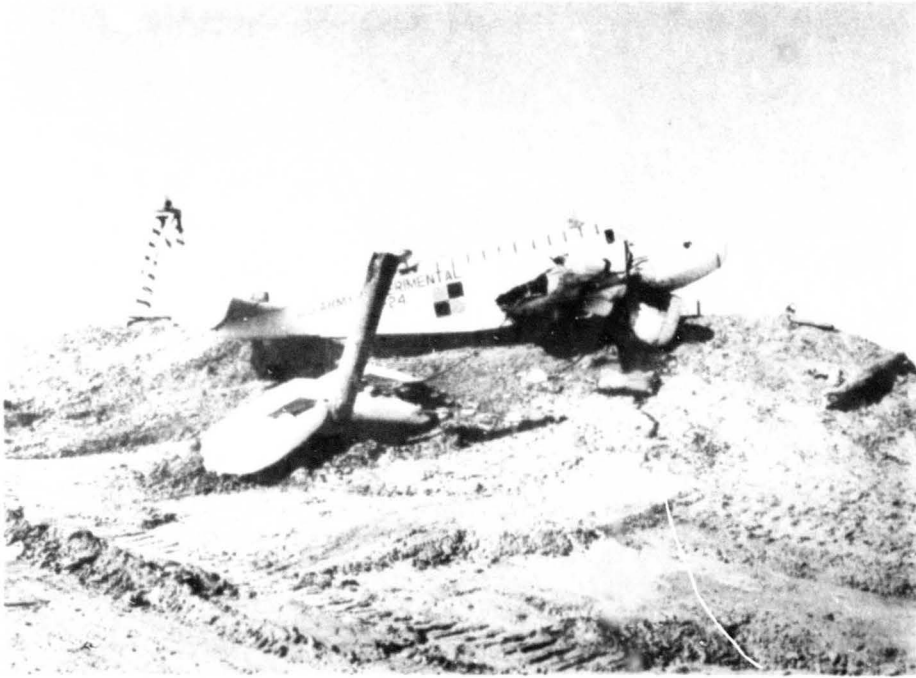
Figure 53. Postcrash View, T-24. (The Right Wing Was Torn Free at Pole Impact, and Remained Wrapped Around the Outboard Pole.)

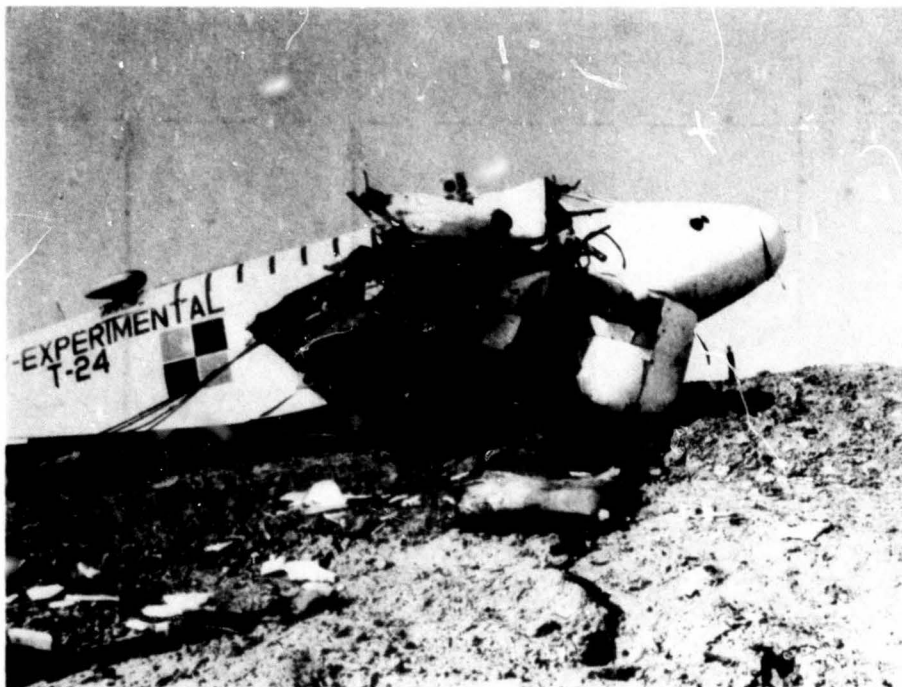
Figure 55. Right-Hand Inboard Tank, T-24. (After the Pole Impact Severed the Wing Through the Fuel Tank Location, the Experimental "Fuzzy Wall" Tank Dropped to the Ground. The Leakage Evident in Figure 55 Is Oil from the Engine, Not Simulated Fuel.)

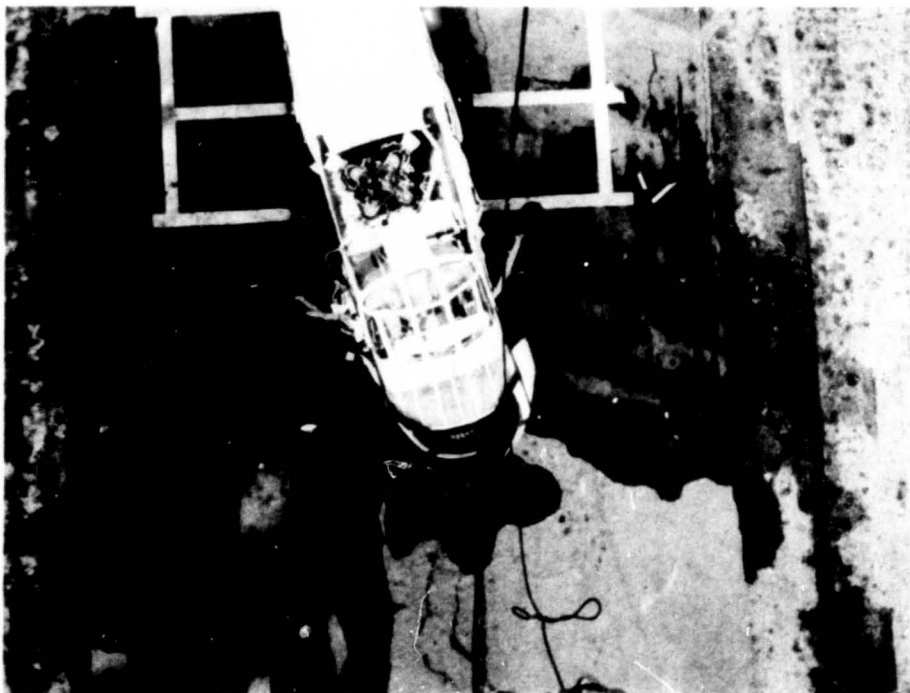
Figure 62. Fluid Spillage, T-17. (Extensive Fluid Spillage Resulted from Failure of Standard Fuel Tanks.)

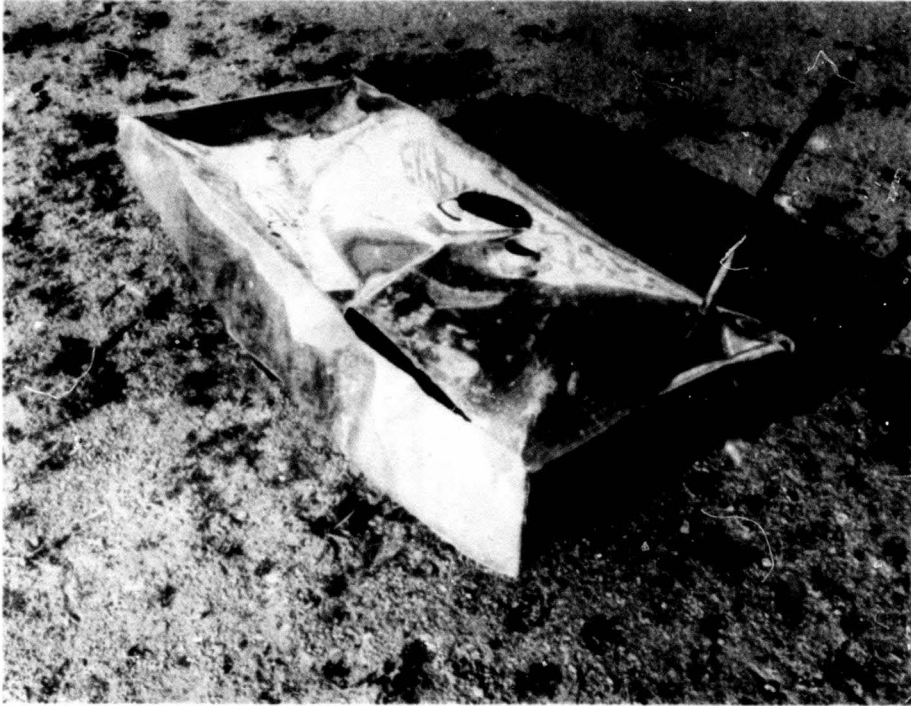
Figure 63. The Ruptured Experimental Aluminum Tank, T-17.

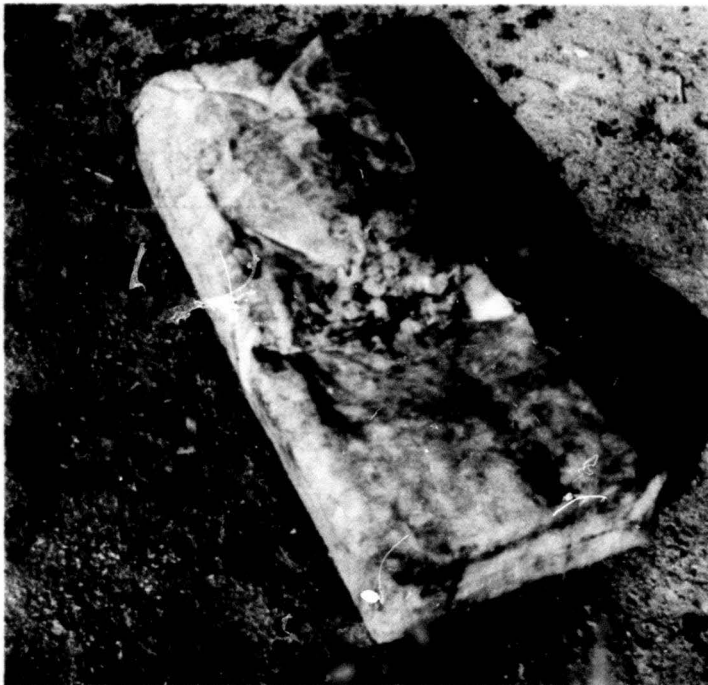
Figure 64. Honeycomb-Cored "Tough Wall" Tank, T-17. (The Only Leakage Occurring in Either Honeycomb-Filled "Tough Wall" Tank Was the Pinhole Seepage Apparent at the Tank Midsection.)

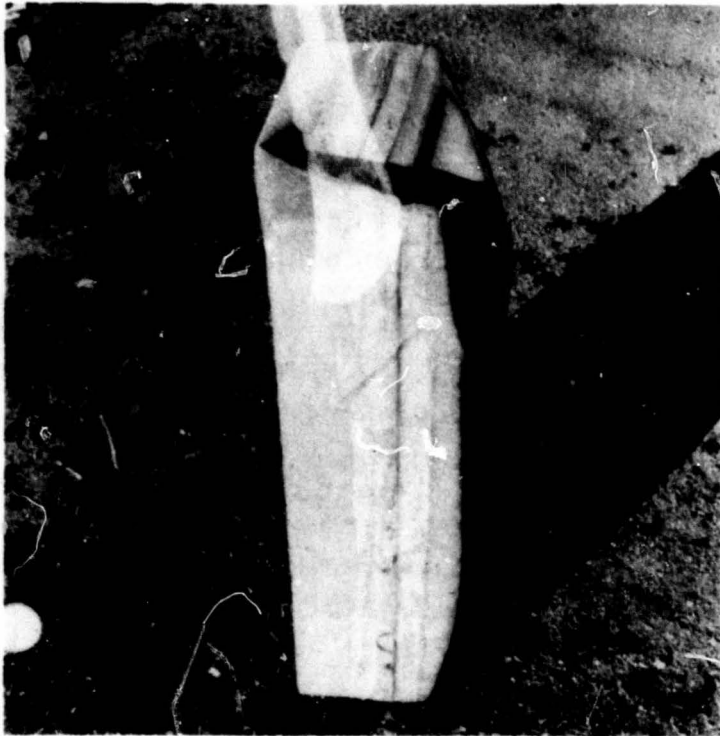
Figure 65. The Hollow "Tough Wall" Tank. (This Tank, Filled to Capacity with Water, Received a Direct Rock Impact and Did Not Fail.)

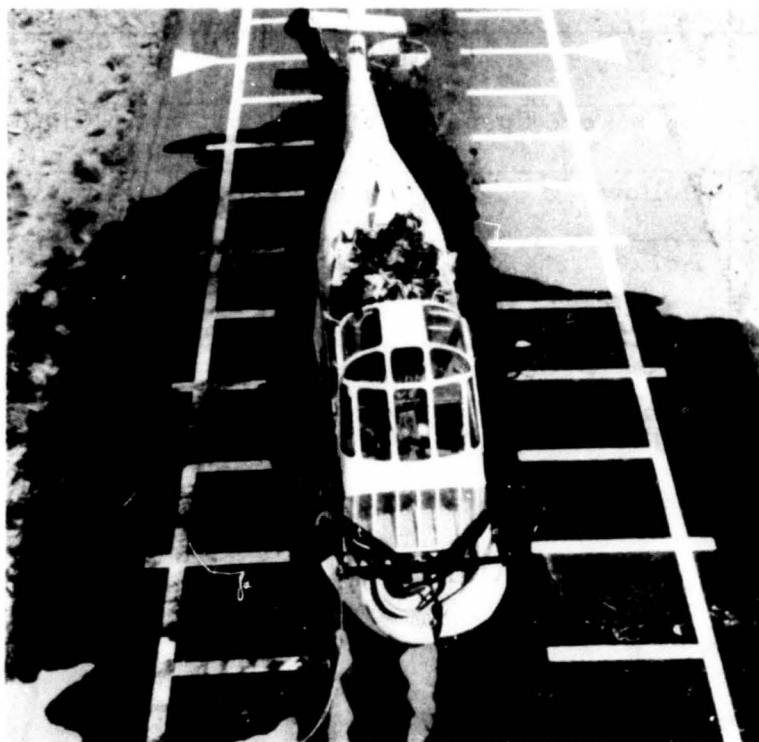
Figure 70. Fluid Spillage, T-23. (Extensive Liquid Dispersion Resulting from Ruptured Fuel Tanks.)

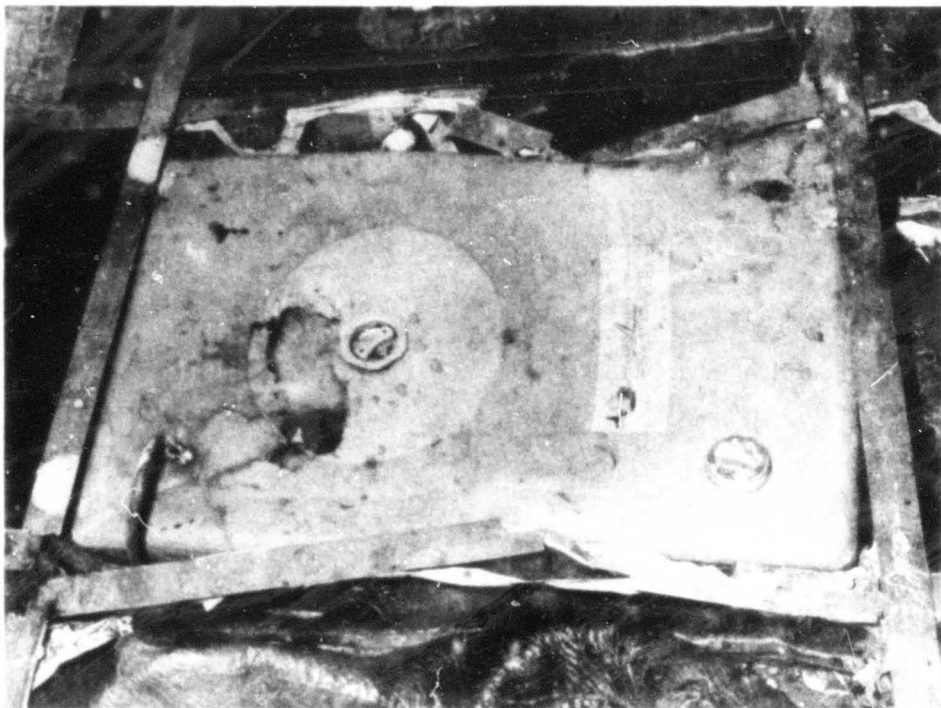
Figure 77. The Hollow "Tough Wall" Tank, T-23. (The Ruptured Tank in Location After Floor Removal.)

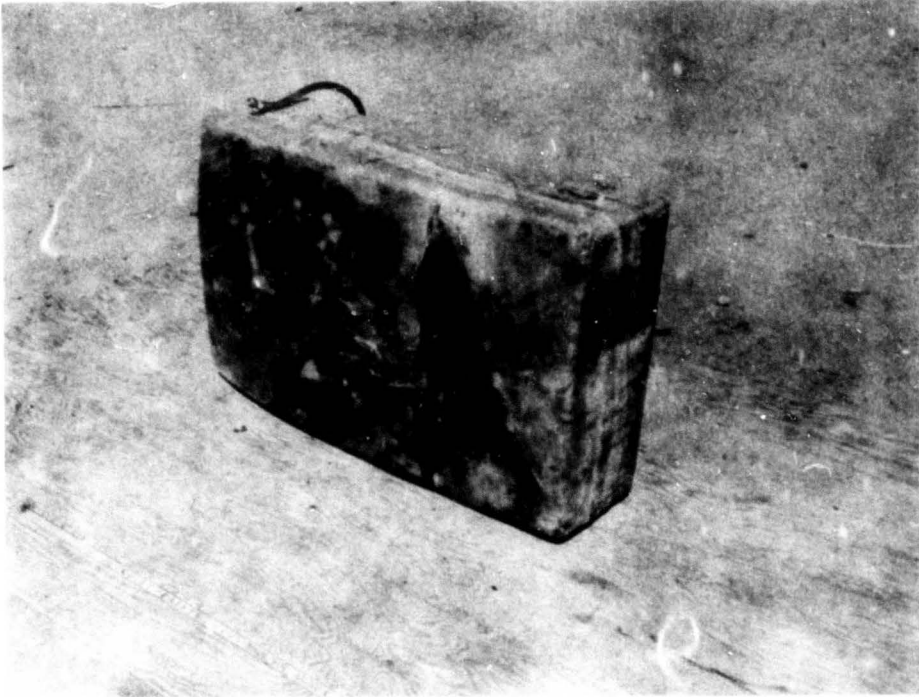
Figure 78. "Tough Wall" Tank Failure, T-23. (The Failure in the Bottom of the Hollow "Tough Wall" Tank Was Due to Rock Impact. The Tank Was Unable To Expand Upward Because of the Modification Made to the Floor To Restrain the Cargo Vertically.)

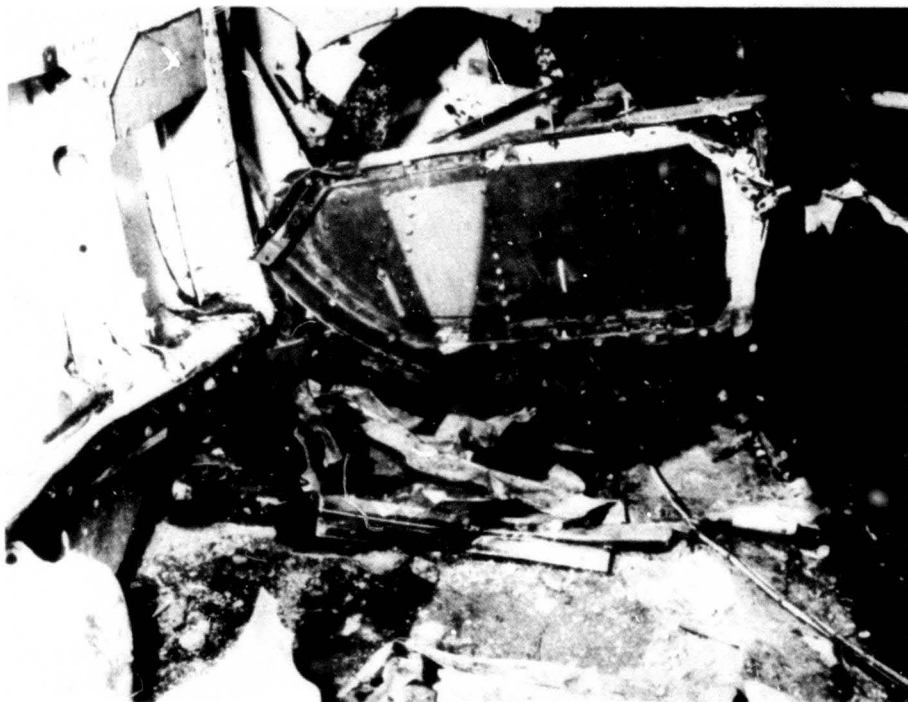
Figure 80. Tank Environment Damage, T-23. (With the "Fuzzy Wall" Tank Removed, the Degree of Structural Failure and Extensive Jagged Metal Surrounding the Tank Installation Are Apparent.)

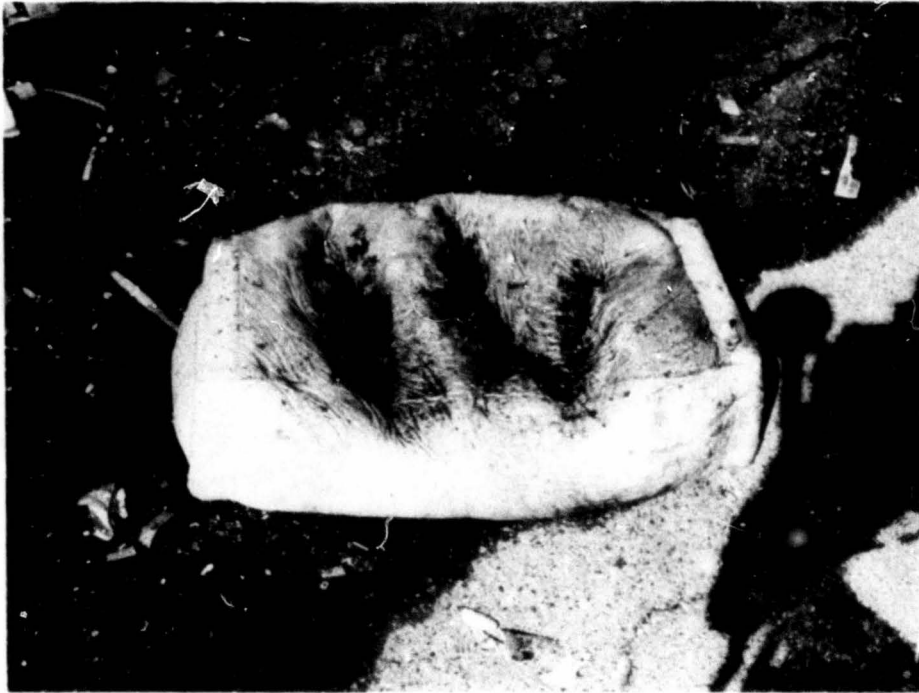
Figure 81. "Fuzzy Wall" Tank, T-23. (The Bulges Apparent on the "Fuzzy Wall" Tank Bottom Are Evidence of the Tank's Ability To Contour and Deform to its Surrounding Environment.)

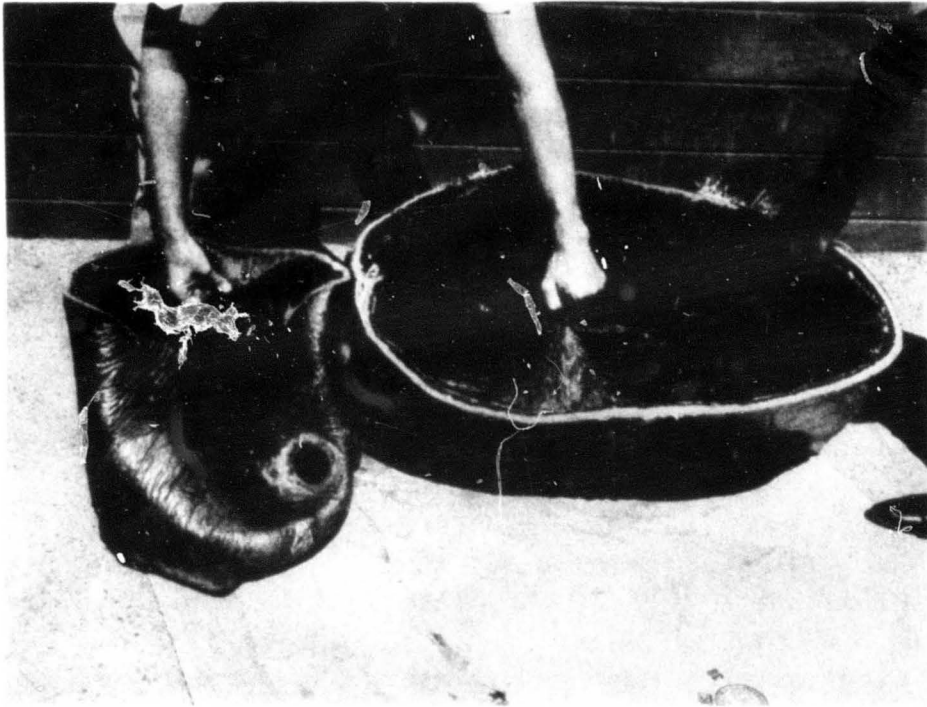
Figure 82. Cross Section of "Fuzzy Wall" Fuel Tank. (Analysis Revealed that the "Crinkl-Core" Has Unfolded in the Lower Regions, Thus Providing an Effective Barrier While the Nylon Pad Elongated. It Was Estimated that this Severe Crash Environment Utilized Less than 20 Percent of the Crashworthy Potential of the Tank.)

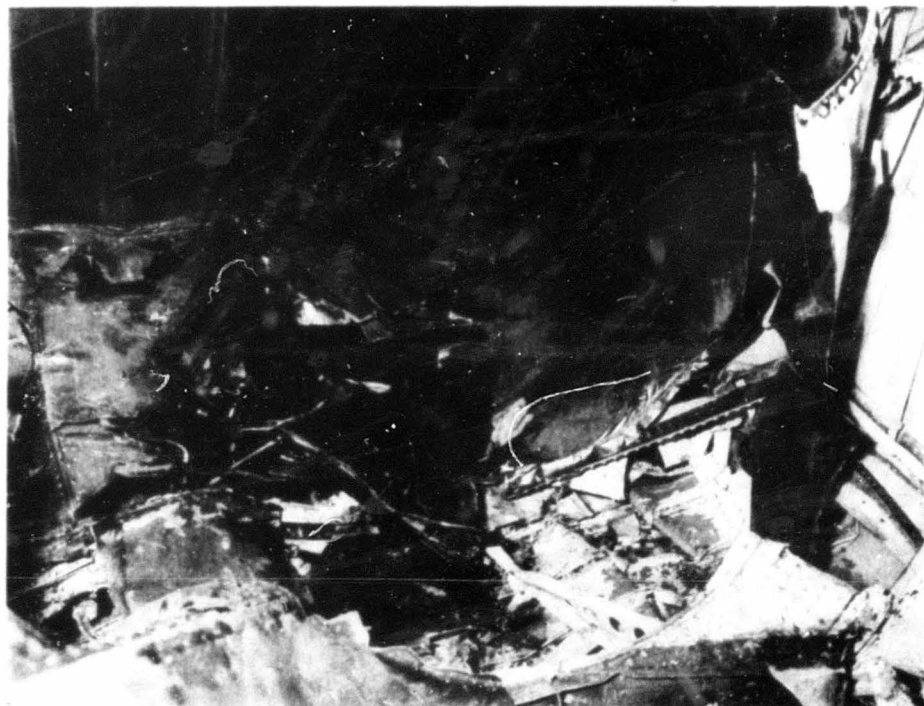
Figure 88. Rock Entry Point, Internal, T-18. (Rock Penetration and Structural Collapse as Viewed From Within the Fuel Tank Cavity.)
